SECTION A MTU ERROR CODES AND TROUBLESHOOTING

A.1 Introduction

Section A provides MTU troubleshooting based on the 2-digit error code displayed on the MTU front panel. Begin troubleshooting by looking up the error code in the MTU Error Code Table beginning on the following page (A0001). A description of the error and a reference to the troubleshooting flow chart (MAP) is given for each error code.

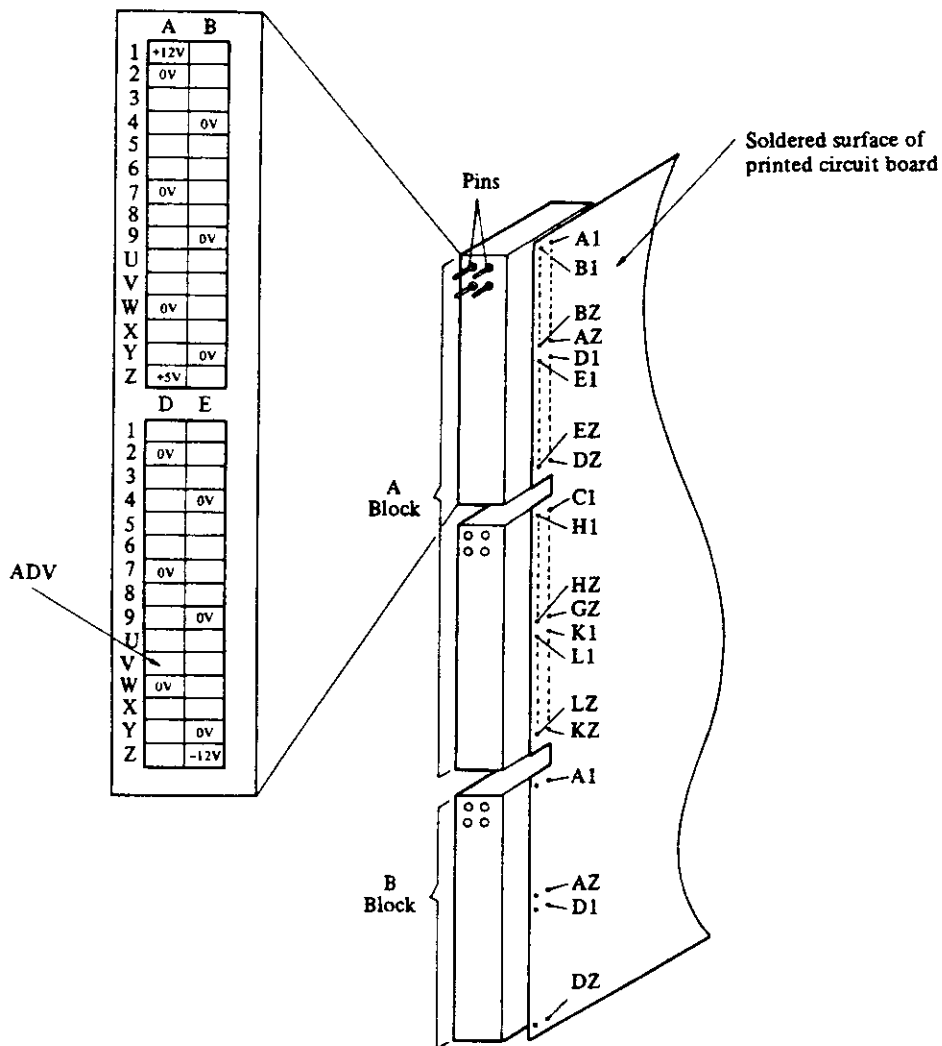
Figure A.1 Signal-monitoring points (pins) on MTU motherboard

Some corrective actions require monitoring a signal at the MTU motherboard. Figure A.1 shows the system by which the pins are identified. The location of pin ADV is given as an example.

Note: ADV location is shown as an example.

- (1) For pin designations such as AE5 on the MTU motherboard, refer to A0020, Figure A.1.

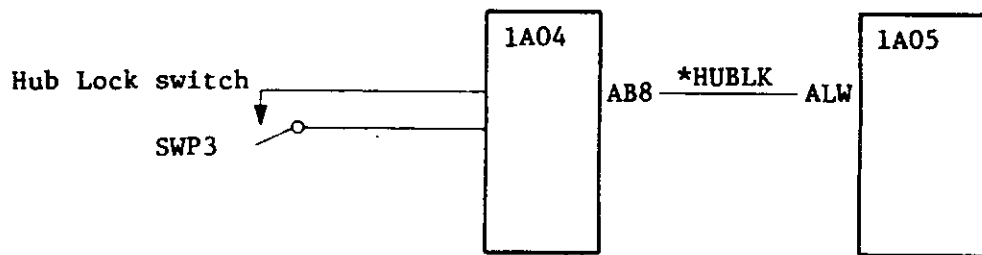
Figure A.3 Troubleshooting Error Codes 13 and 32

Either RTLAL (right tape loop alarm) LTLAL (left tape loop alarm), HUBAL (hub lock alarm) ECER (erase circuit error), WCER (write circuit error), or WRIST (write/read PCA installed) is incorrectly set.

- (1) File address \$1A:
 Bit 0 RTLAL: Right tape loop alarm
 Bit 1 LTLAL: Left tape loop alarm
 Bit 2 HUBAL: Hub lock alarm
 Bit 3 ECER: Erase circuit error
 Bit 4 WCER: Write/read installed.
- (2) If necessary, refer to Part I of this manual for instructions on how to display a register file address using the field tester.
- (3) Refer to Section L for subassembly removal and replacement instructions.

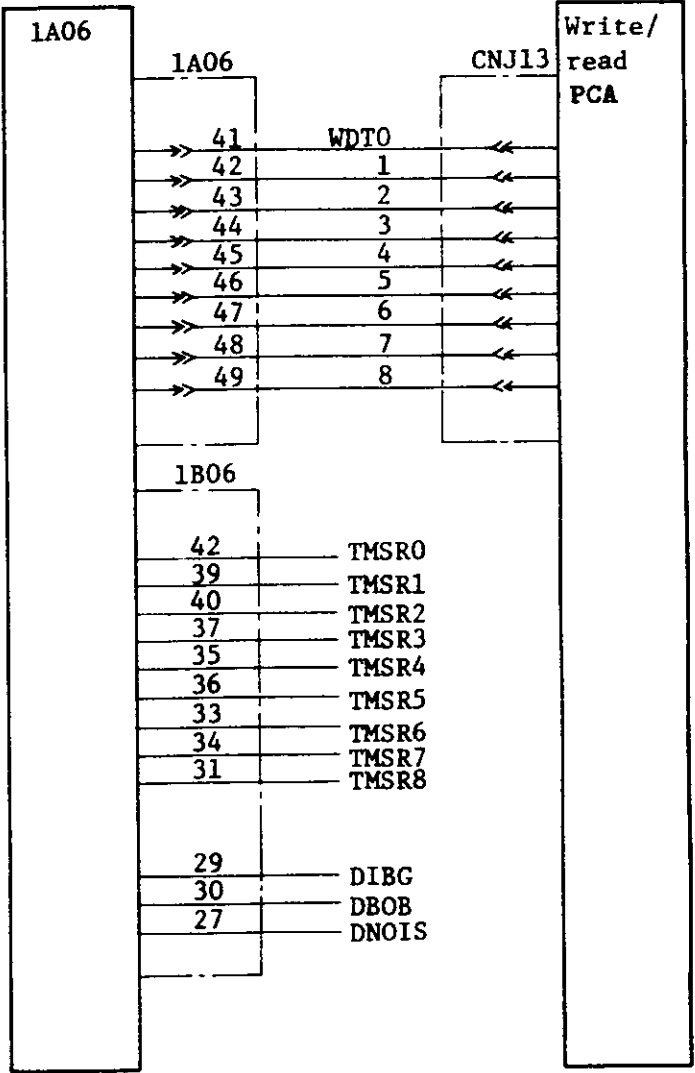
Figure A.7 Troubleshooting Error Codes 22 through 25

Abnormality on file address \$1E and \$1F.

Read	Write
Bit 0 TMSR0: Time sensor 0	0	1
Bit 1 TMSR1: Time sensor 1	0	1
Bit 2 TMSR2: Time sensor 2	0	1
Bit 3 TMSR3: Time sensor 3	0	1
Bit 4 TMSR4: Time sensor 4	0	1
Bit 5 TMSR5: Time sensor 5	0	1
Bit 6 TMSR6: Time sensor 6	0	1
Bit 7 TMSR7: Time sensor 7	0	1

Read	Write
Bit 0 GOB : Go tag	0	0
Bit 1 STS : Status flag	0	0
Bit 2 TMSR8: Time sensor 8	1	0
Bit 3 DNOIS: Detected noise	1	0
Bit 4 DBOB : Detected beginning of block	1	0
Bit 5 DIBG : Detected inter block gap	0	1
Bit 6 DTM : Detected tape mark	0	0
Bit 7 0 : Logical '0'.	0	0

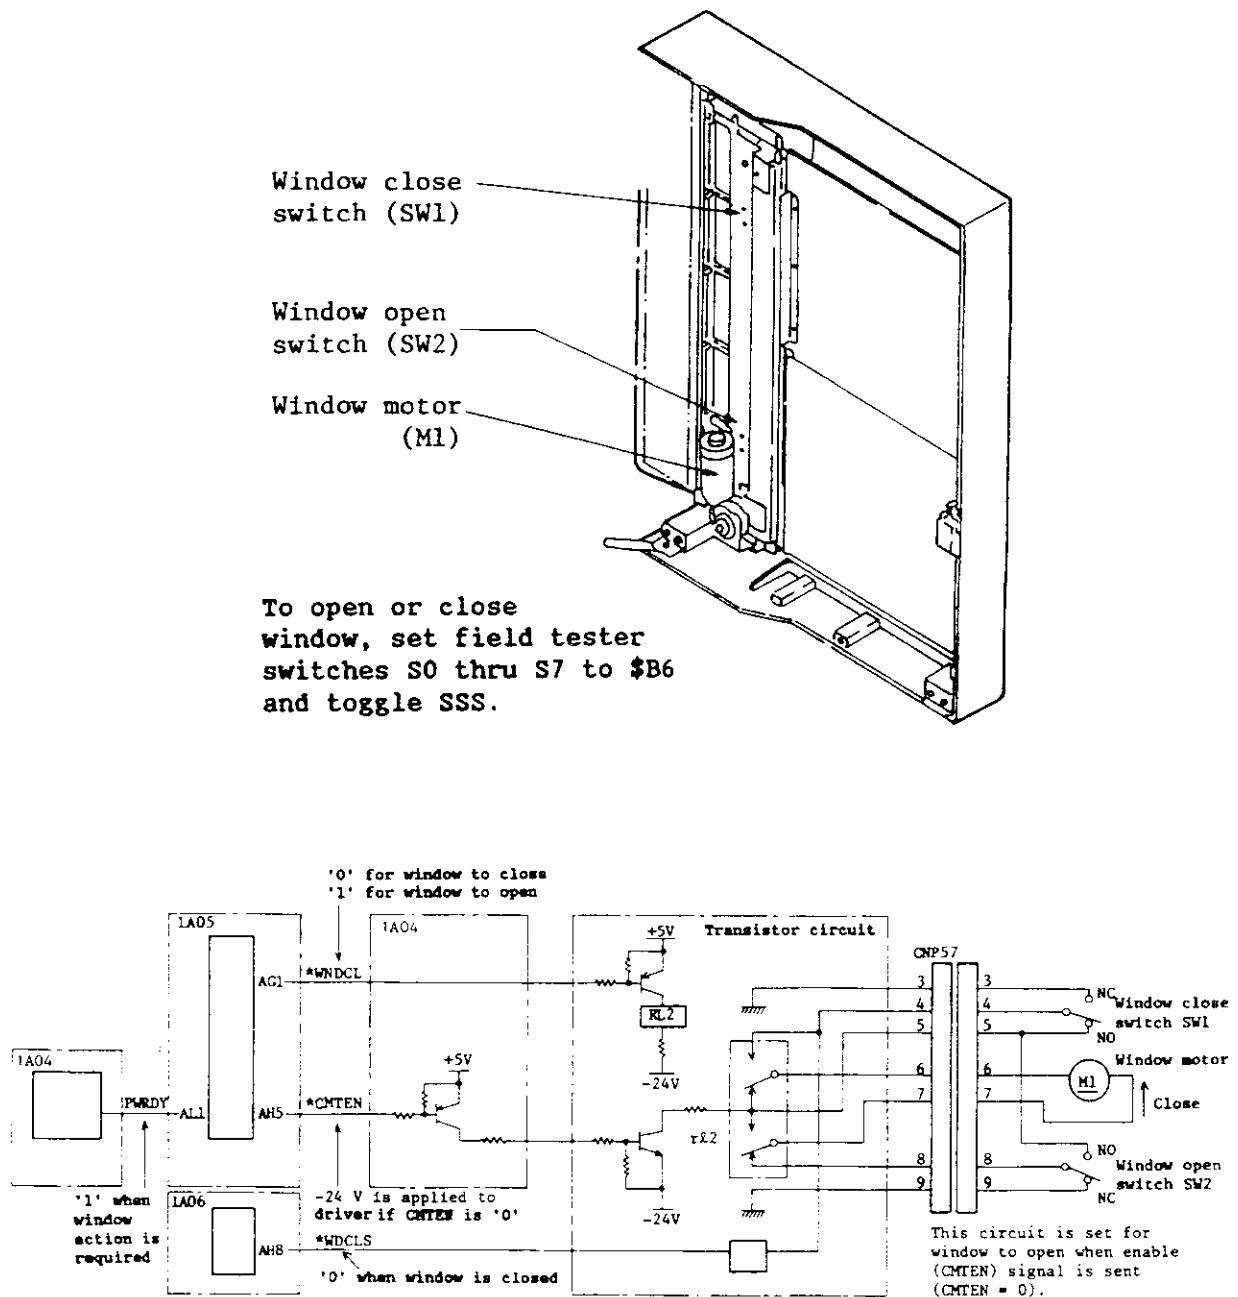
Figure A.8 Troubleshooting Error Code 31

Window open/close failure.

- (1) Window open/close failure is due to drive system, microprograms, or mechanism.
- (2) Use the field tester to issue command \$B6 to open and close the window.

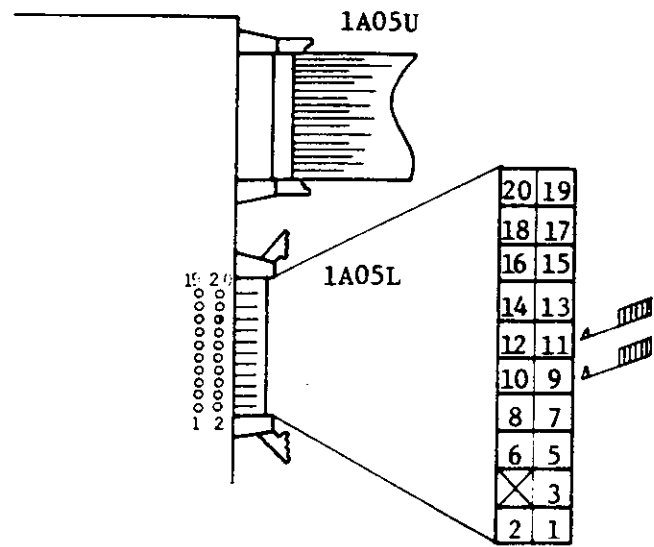
Figure A.10 Timing chart for air supply motor

Logic PCA at 1A05

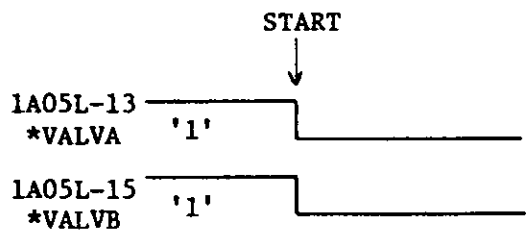
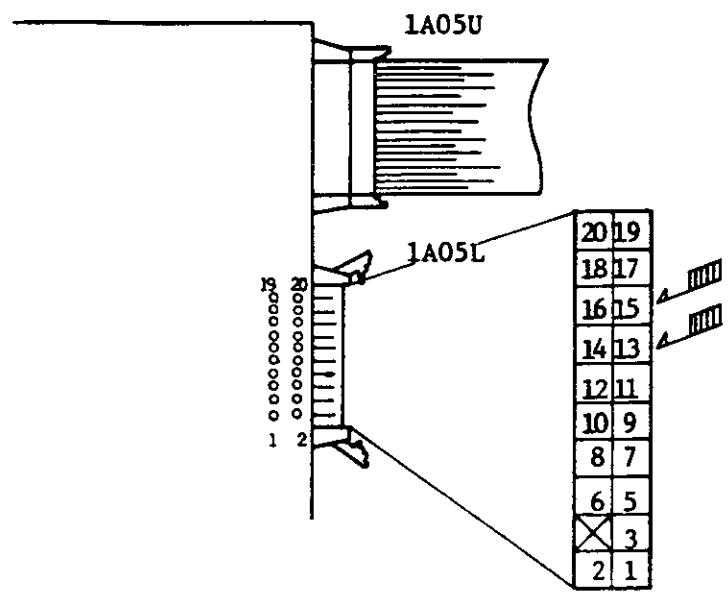
Figure A.11 Timing chart for pressure and solenoid valves

Logic PCA at 1A05

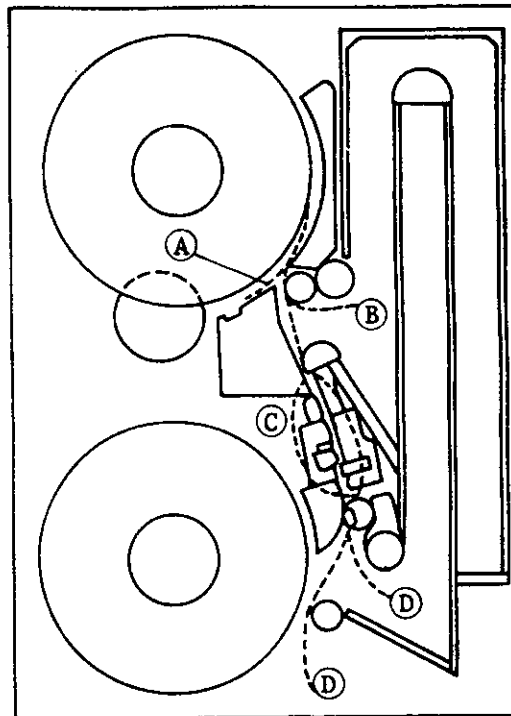
Figure A.14 Tape positions

- (1) Tape does not wind onto machine reel even though it has been loaded from file reel.
- (2) See accompanying figure for referenced tape positions (pos).

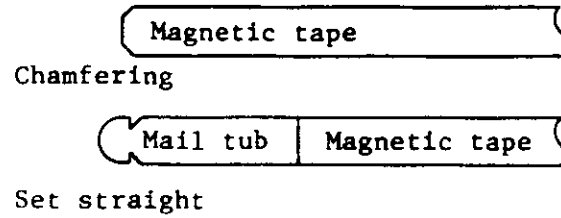
Figure A.21 Tape rim end

Tape did not reach BOT sensor.

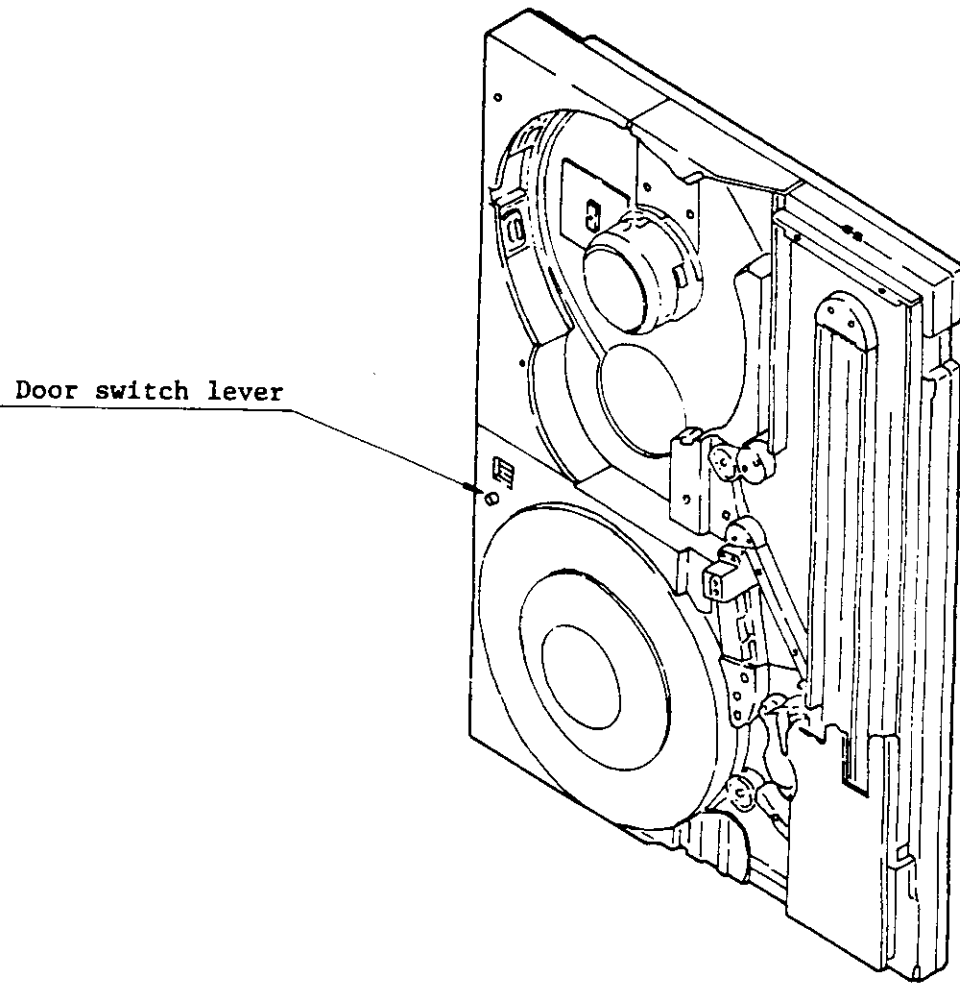
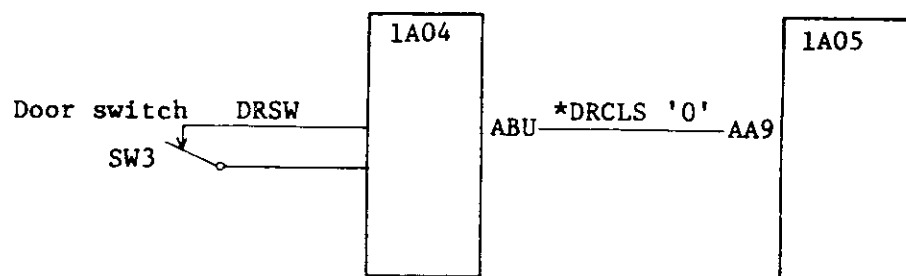
Figure A.24 Troubleshooting Error Codes 35, 40, and 65

See A0020, Figure A.1 pin location on the MTU motherboard.

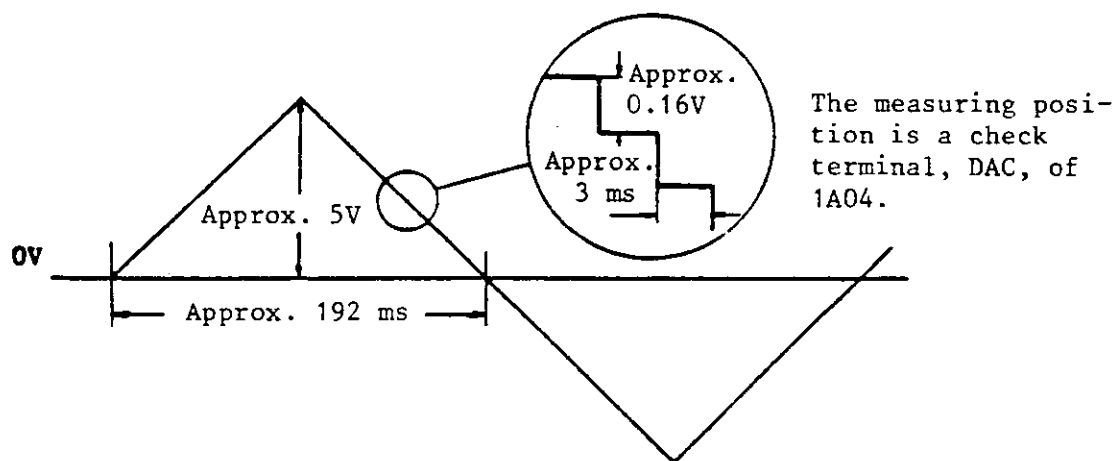
Figure A.26 Troubleshooting Error Codes 72 and 73

Note: See A0020, Figure A.1 for ADV pin location on the MTU motherboard.

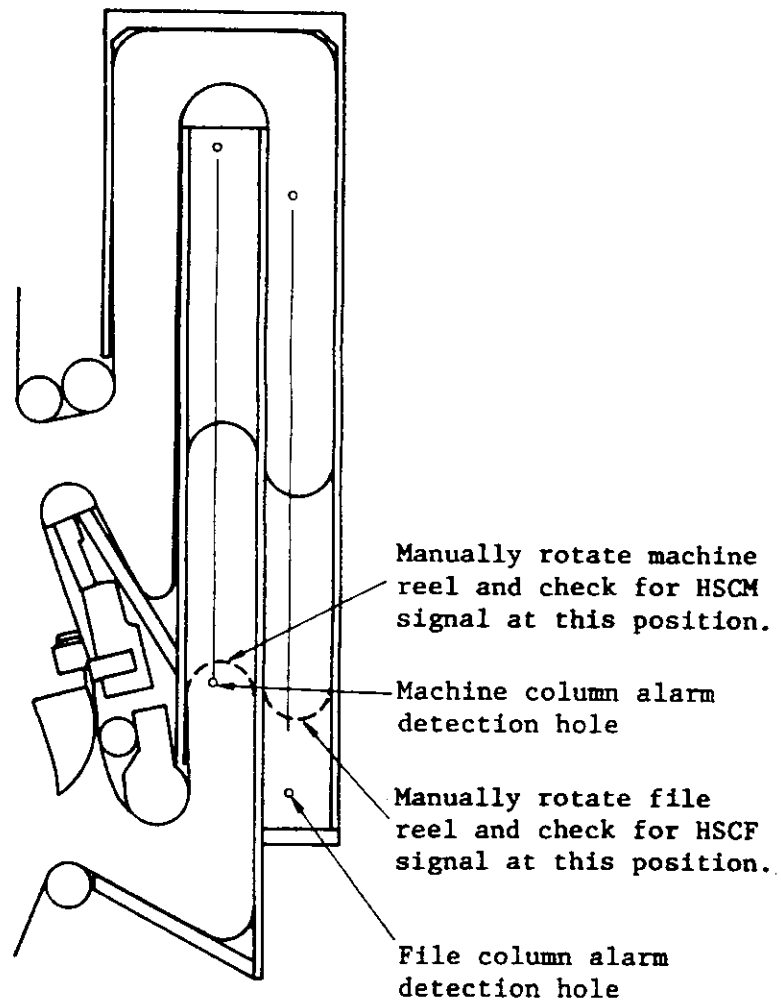
Figure A.28 Tape loop in columns

Tape Loop Trouble in Columns (200 to 600 ips, and 600 to 200 ips)

Notes: After tape is rewound for 0.5 seconds at 200 ips, tape speed accelerates gradually by 40 ips per 100 ms if speed down signal (HSCM/HSCF) from reel controller does not become '1'. Speed decelerates gradually by 40 ips per 100 ms if speed down signal becomes '1'. If low tape marker is detected, then tape speed decelerates gradually at intervals of 100 ms.

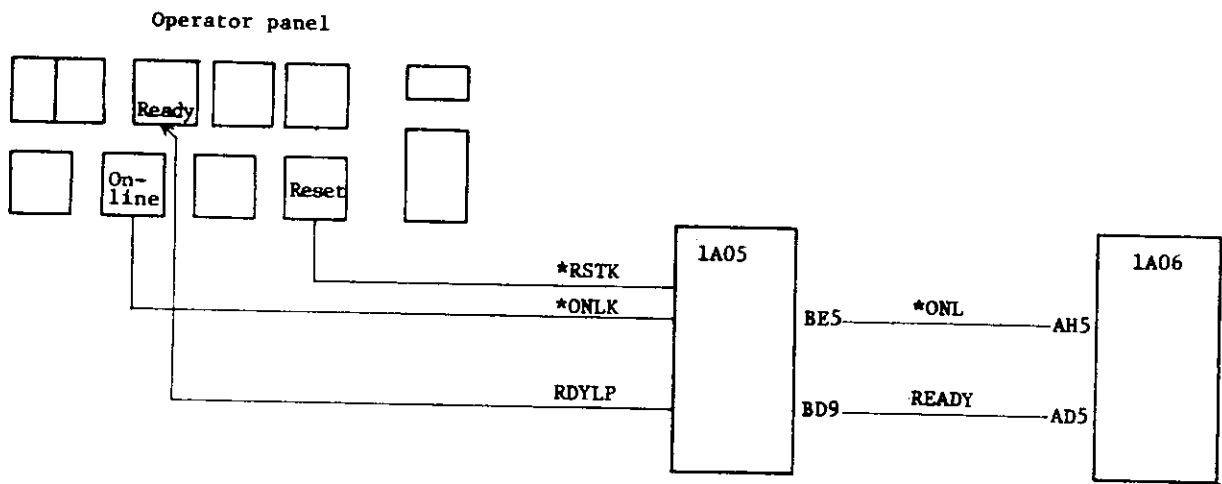
Figure A.31 Ready troubleshooting

A4000 Ready Troubleshooting

Notes: After loading magnetic tape:

1. When ONLINE button is pressed ONL (online) is set to '0' and READY is set to '1', then READY lamp lights.
2. When RESET button is pressed, ONL is set to '1' and READY is set to '0', then READY lamp goes out.

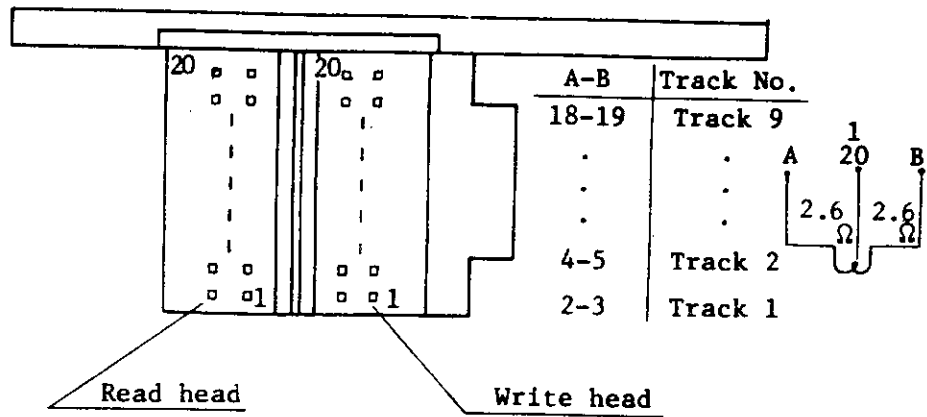
Figure A.38 Read/write head (viewed from head connector side)

Abnormality for Read Level (1600/800 rpi MTU).
